ARCHAEOLOGICAL INVESTIGATIONS OF THE KIOWA AND COMANCHE INDIAN AGENCY COMMISSARIES

34-Cm-232

Contributions of the Museum of the Great Plains, Number 7, Lawton, Oklahoma

Submitted in partial fulfillment of
Contract No. DACA63.76-C-0256
Corps of Engineers, Fort Worth District

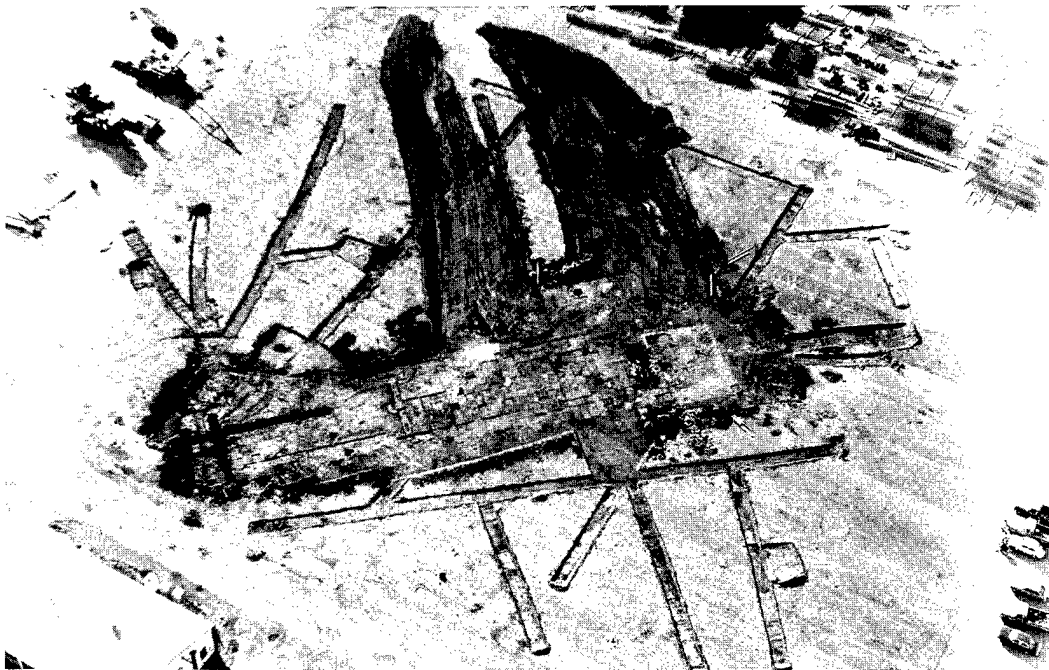
Figure 3-2. Aerial View of Site.

All of this material was concentrated in the area of the suspected west building (Figure 3-2). The trenching more than adequately indicated that little if anything was to be gained by further explorations into the area of the east building and that nothing at all was present to the west of the structure defined as the west Commissary. Hand excavation therefore, was oriented almost entirely toward maximum recovery from the west building area. Within that area, the density of artifacts was highest toward the south end, known to have been the location of the Agent's residence. It seemed appropriate then that excavations should begin here.

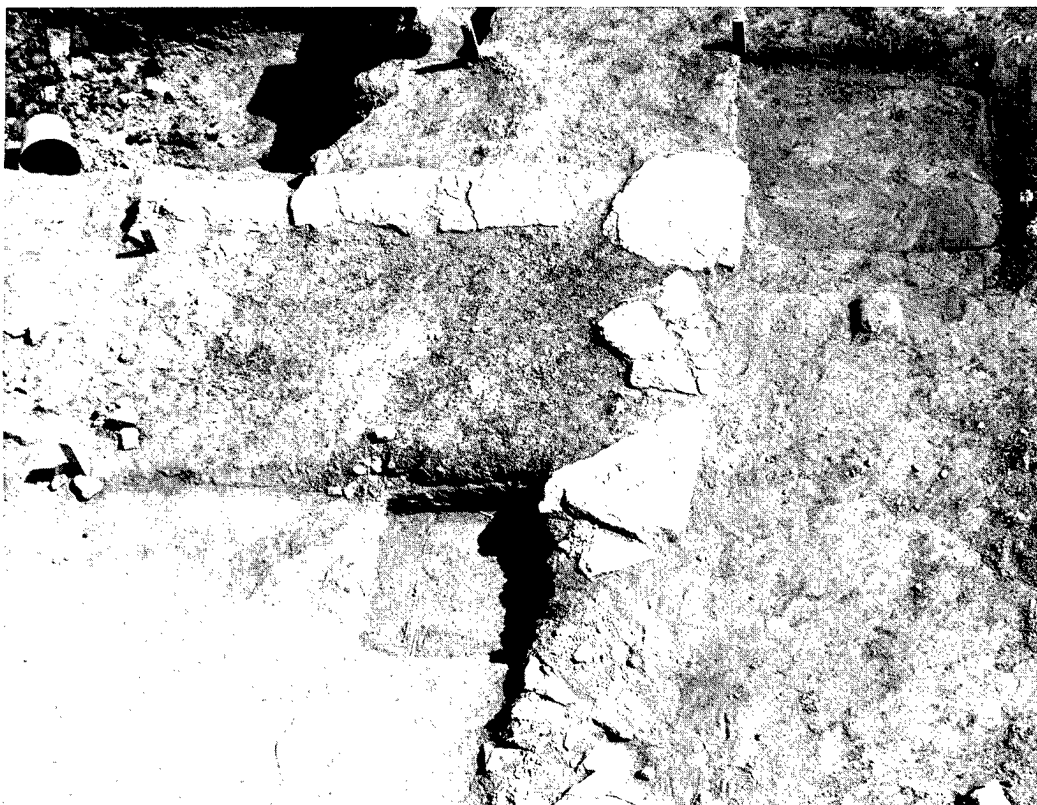
Figure 4-1. Feature 5.

This was an alignment of thin tabular limestone blocks in an arrangement implying association both with the building itself and with Feature 8, discussed below. The south-north arm of this alignment is directly along what is thought to have been the east wall of the west building apparent also in the distribution of plaster over the site (Map 1; Figure 3-2). This alignment (Figure 4-1) turns 90 degrees to the west immediately below the Feature 8 pit. The stones themselves are laid so as to present a faced edge to the north and to the east. It is only one stone in thickness with no obvious mortar or other binder between and has been laid directly on the clay subsoil with no apparent preparation. Measurements were made of the thickness of these. The two stones at the east end of the alignment measured 3.3 inches (85 mm.) and 2.6 inches (65 mm.) in thickness. That in the northeast corner was 4.13 inches (105 mm.) in maximum thickness.

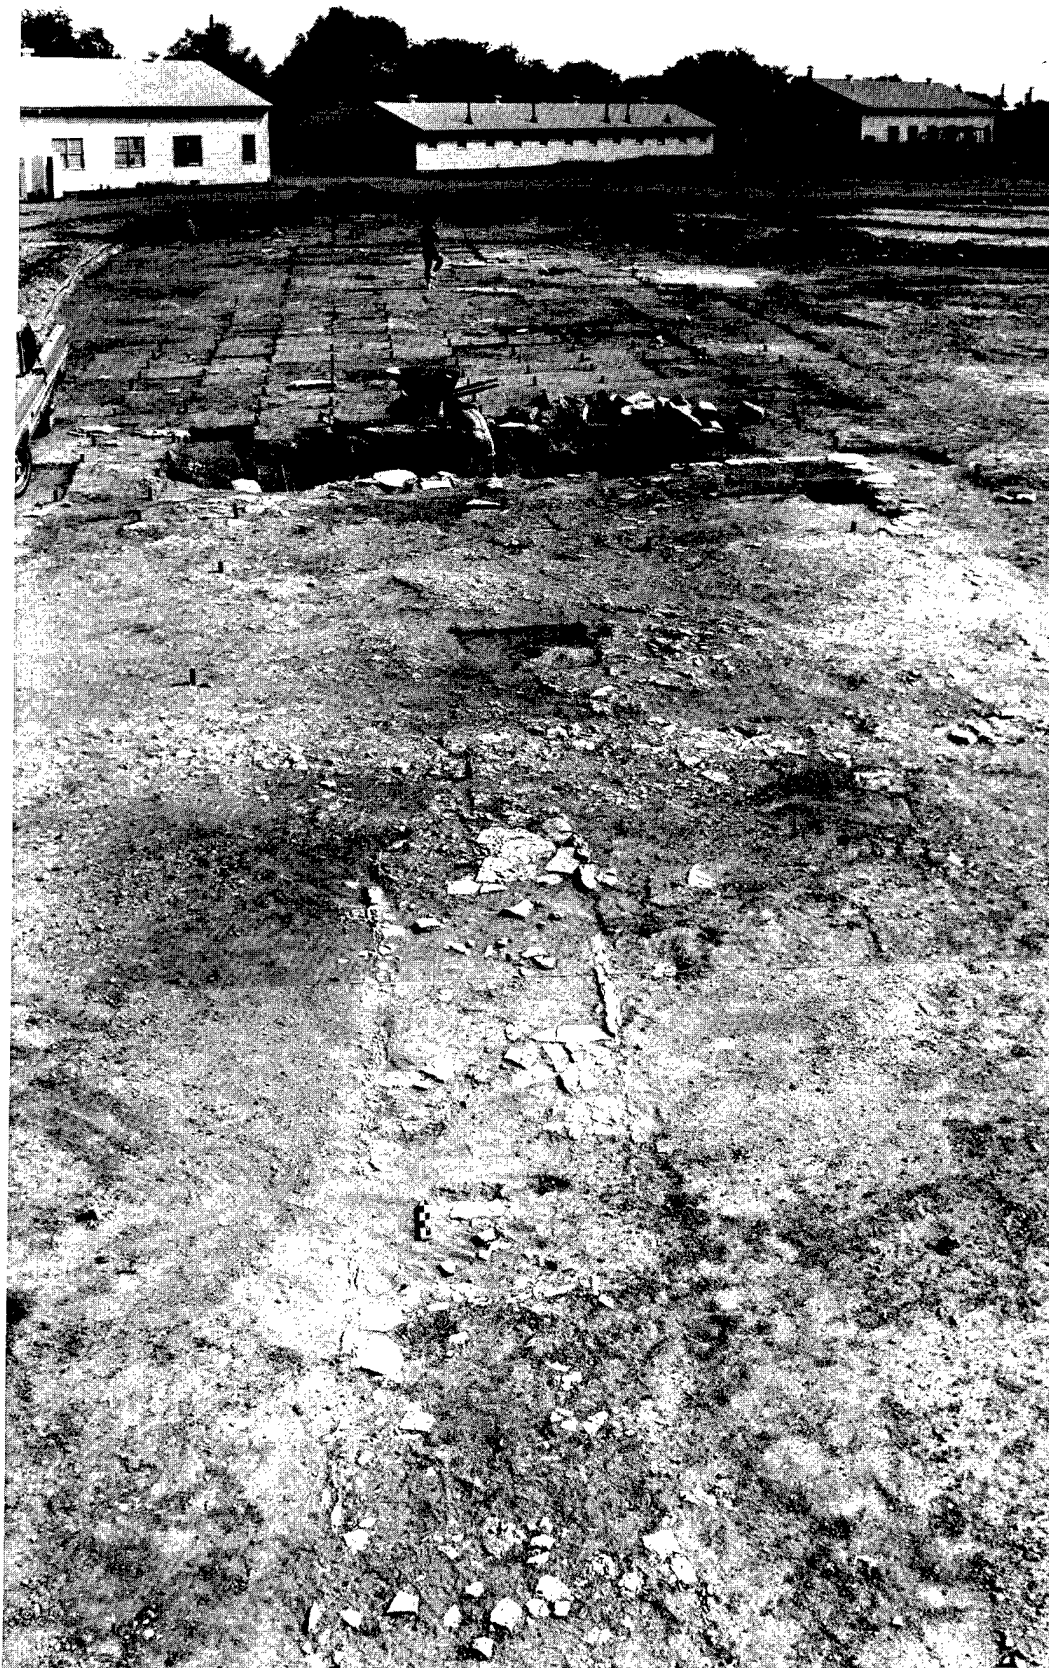
This double alignment of upright limestone tablets was a walk leading across the front yard and up to the front of the building (Figure 4-3). It had not been previously known because of the fence around the Commissary yard shielding it from view. From the inside of upright to the inside of upright, width was 37.4 inches (95 cm.). These are oriented north-south, that is along the same axis as the building itself. These uprights had begun to split but those which were measured varied from 2.0 to 3.0 inches (50 to 75 mm.) in thickness and appear to have been deliberately faced to the inside of the walk and perhaps to the outside as well. Tabular limestone was laid between the uprights. These appear to have been originally emplaced larger stone with some smaller fill between but when examined the larger were fragmented and unevenly distributed. There was a wide range of sizes but the largest was about 12.6 by 7.9 inches (32 by 20 cm.).

Figure 4-3. View Across Site Looking North. Note Feature 6 in foreground and Features 5, 8, and 9 in background.

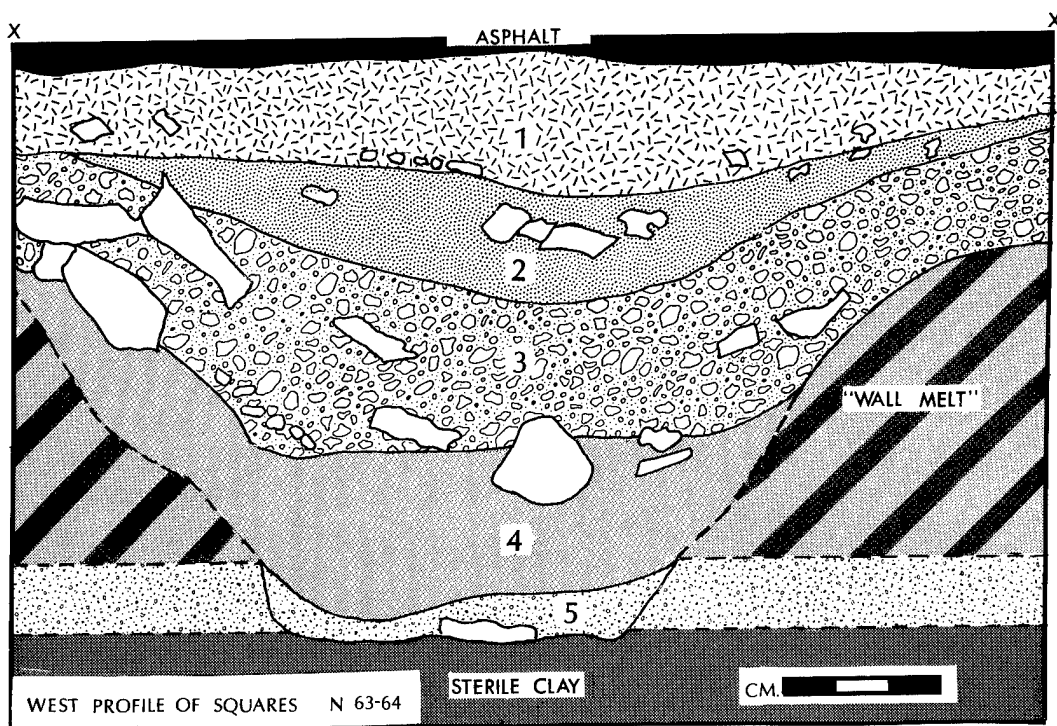
Figure 4-5. Feature 8 Cross-section. Level 1: Chat fill; Level 2: Mixed occupational debris; Level 3: Heavy rock fall; Level 4: Orange and brown "wall melt"; Level 5: Plaster and mortar fall.

The question of pit use naturally arises. It is one for which no suitable solution has yet been found. Possibilities which have been expressed are a root cellar, a storm cellar, and a treasure hunter's hole. The regularity of its form as well as the stone alignment, Feature 5, do not make this appear to be random or hastily dug as would be the case with the latter. The heavy concentration of large plaster chunks in level 5 make it appear to have existed prior to the demise of the building and to have been filled when the building was

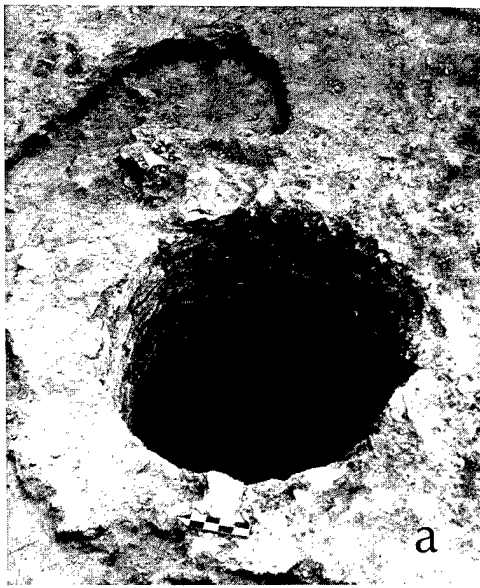
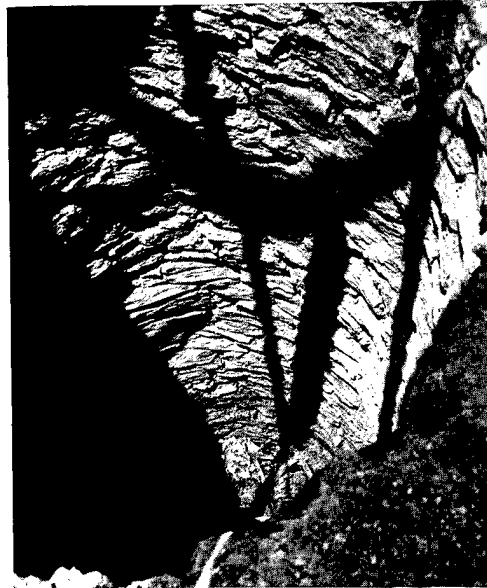
As excavation continued it became apparent that only the upper 4.6 feet (1.4 meters) of the wall were mortared in place. Below that the stone had been simply dry stacked. Well diameter varies somewhat as it was not perfectly circular through its entire depth. However, diameter at ground level was 1.10 meters. At just under 30 feet (about 9 meters) depth, the false floor collapsed out from under the excavator, who fortunately had his safety harness in place. It disappeared into somewhat murky waters below. Present water level is at 32.3 feet (9.85 m.) depth.

Figure 4-7. Feature 10. a. the well as it appeared at ground surface, b. view down well during excavation.

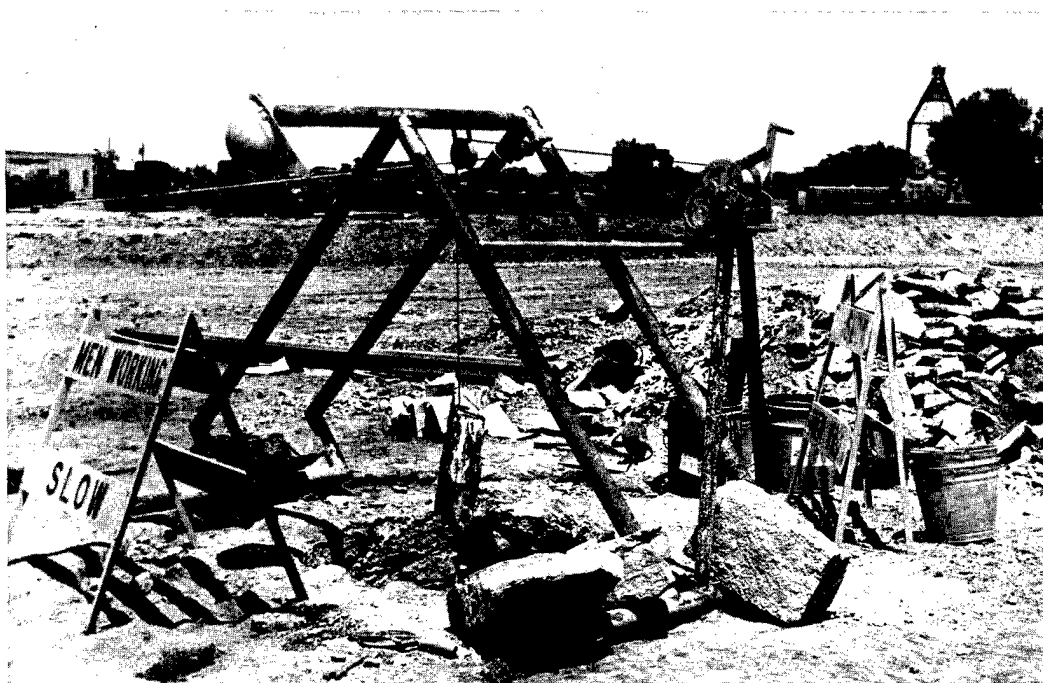
Figure 4-8. Pulley Assembly Used for Well Excavation.

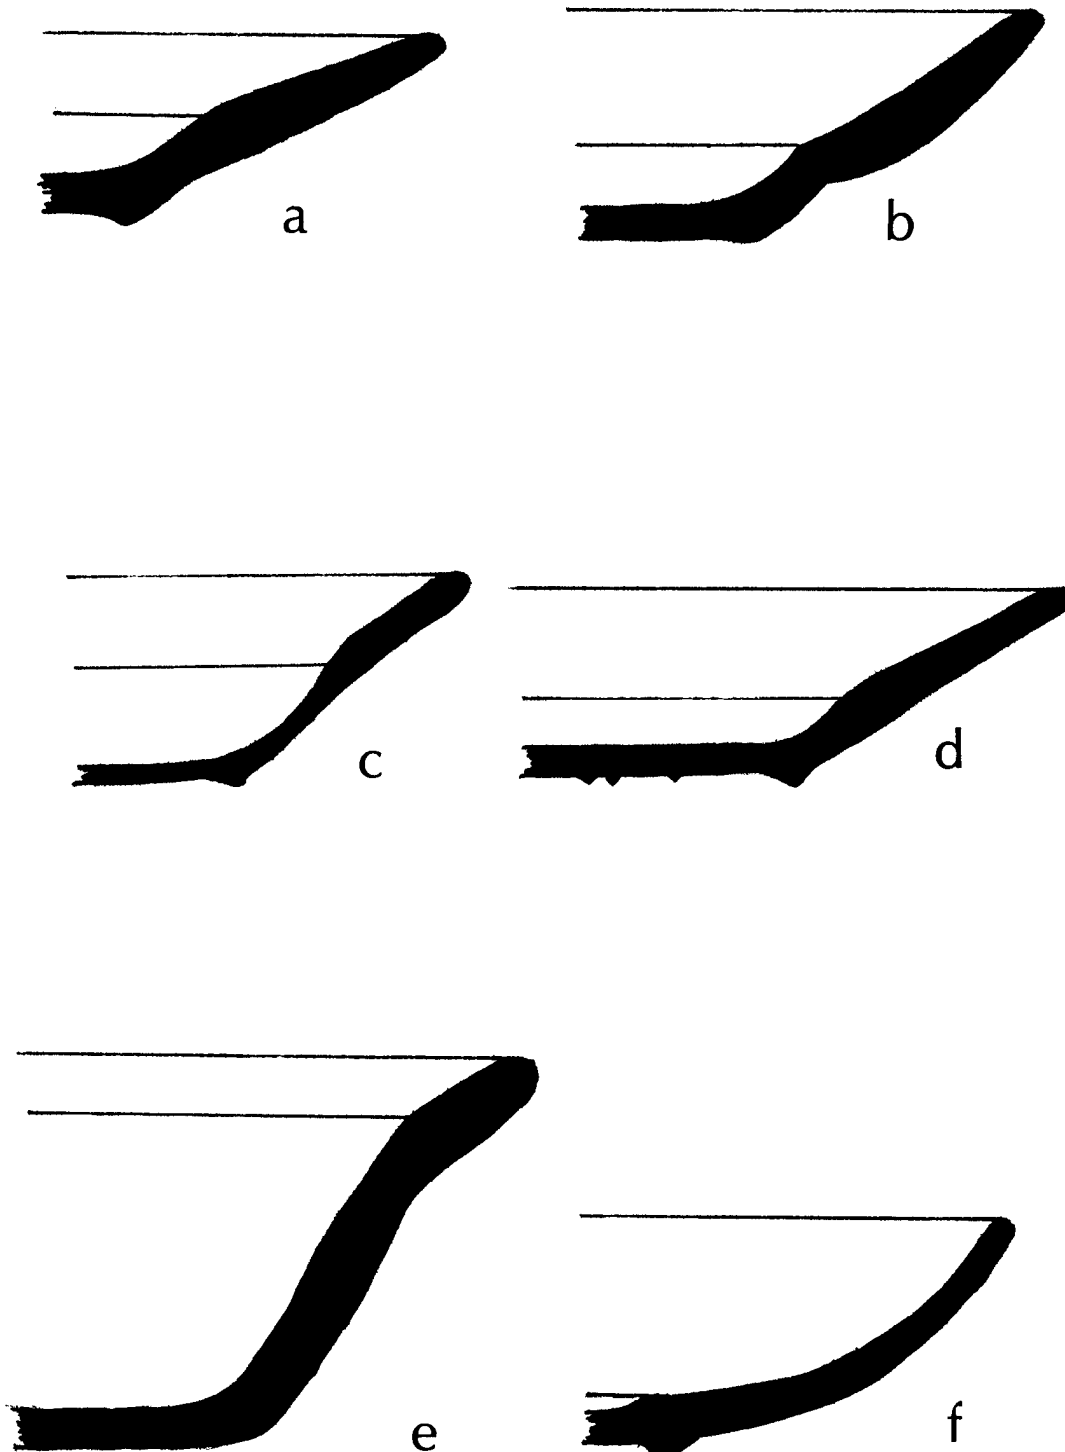
Figure 5-3. Ironstone/Whiteware Ceramic Profiles. a. plate, b. "George Jones" plate, c. small bowl, d. "Henry Alcock" plate, e. large bowl, f. saucer/vegetable dish.

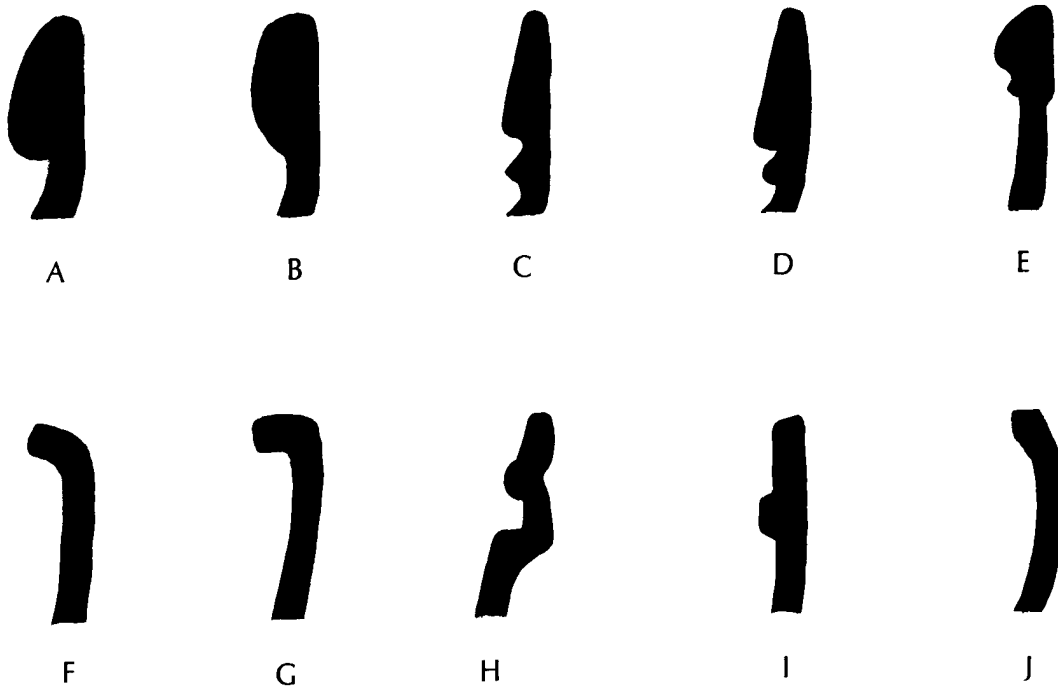
Figure 5-5. Generalized Bottle Mouth Finishes. a. tulip, b. beaded, c. "under ridge," d. "under ring," e. double ring, f. bevel collared, g. flat collared, h. screw, i. banded, j. simple rimmed.

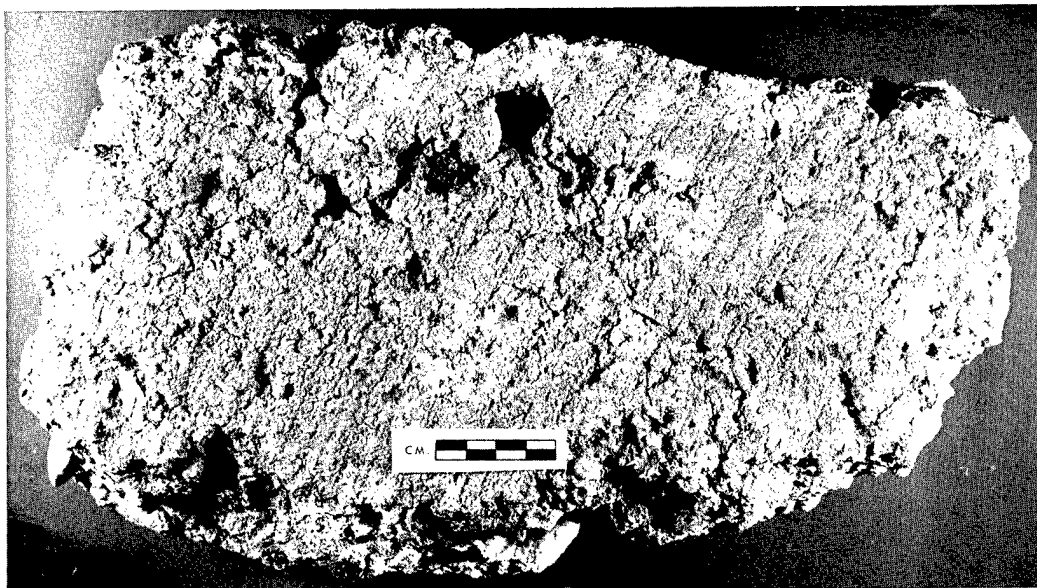
Figure 6-4. Concrete "Footing." (Note presence of radial saw marks on block face.)

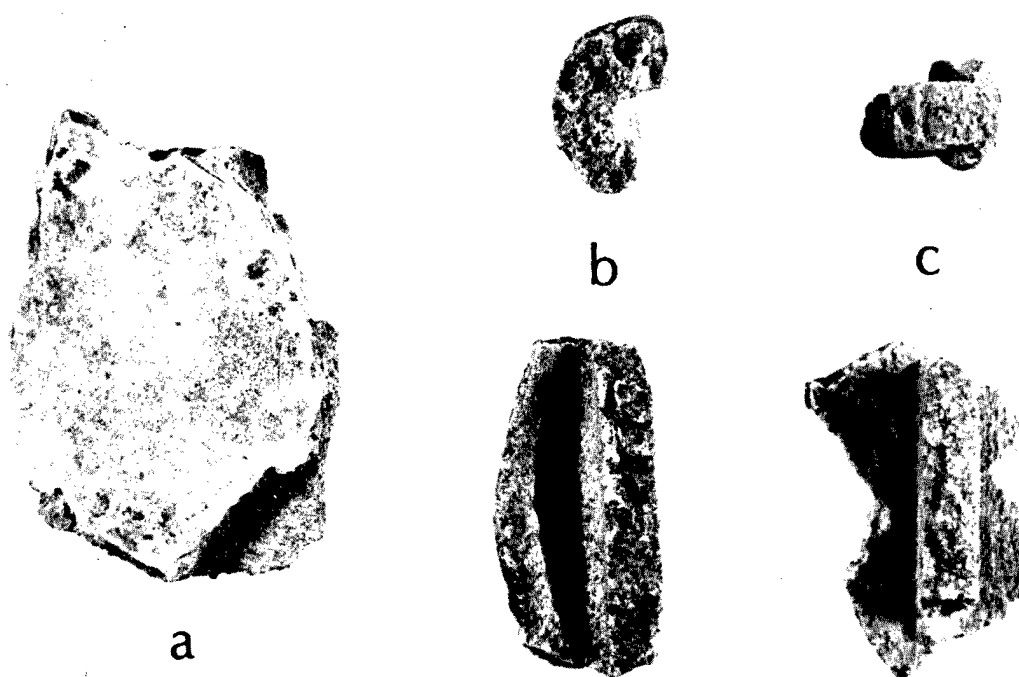
Figure 6-6. Wall Plaster. a. whitewashed outer plaster face (note presence of multiple coats), b. side and front view of broken, curved plaster "key," c. side and back view of straight "key" still attached to outer plaster coat

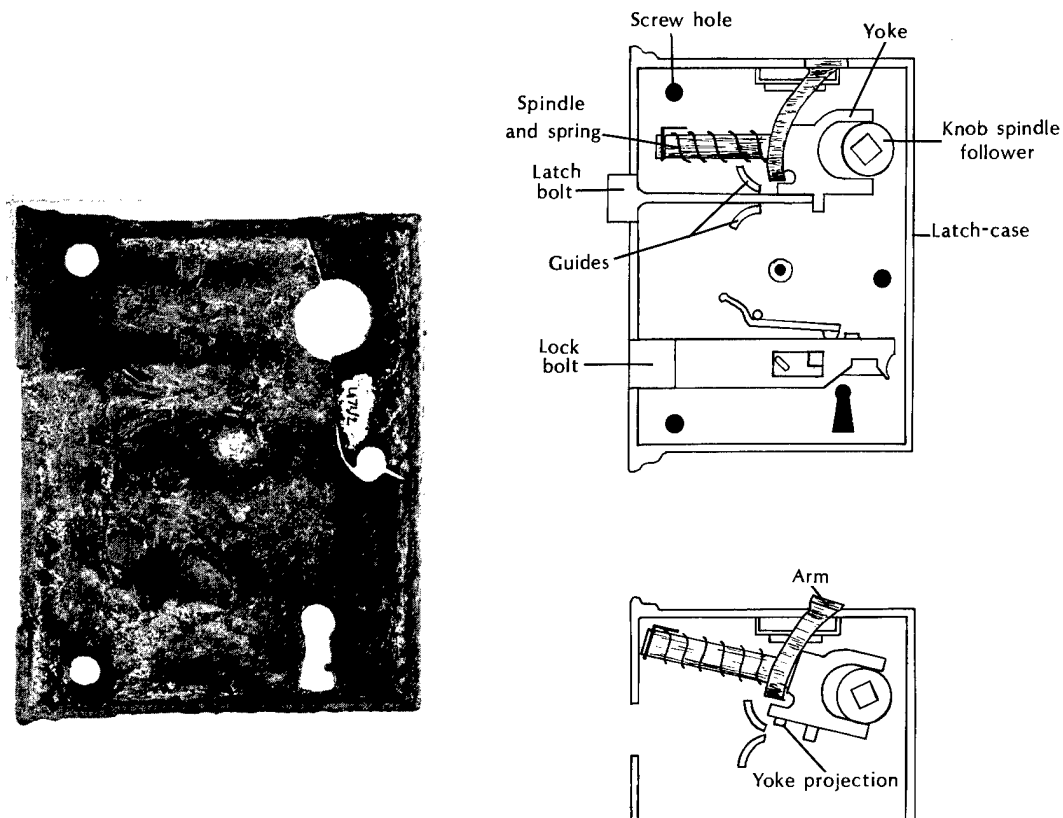
Figure 6-9. Parker Patent Rimlock. left- detail of rimlock body found at Cm-232; right- reproduction of drawing accompanying Patent No. 77,909.

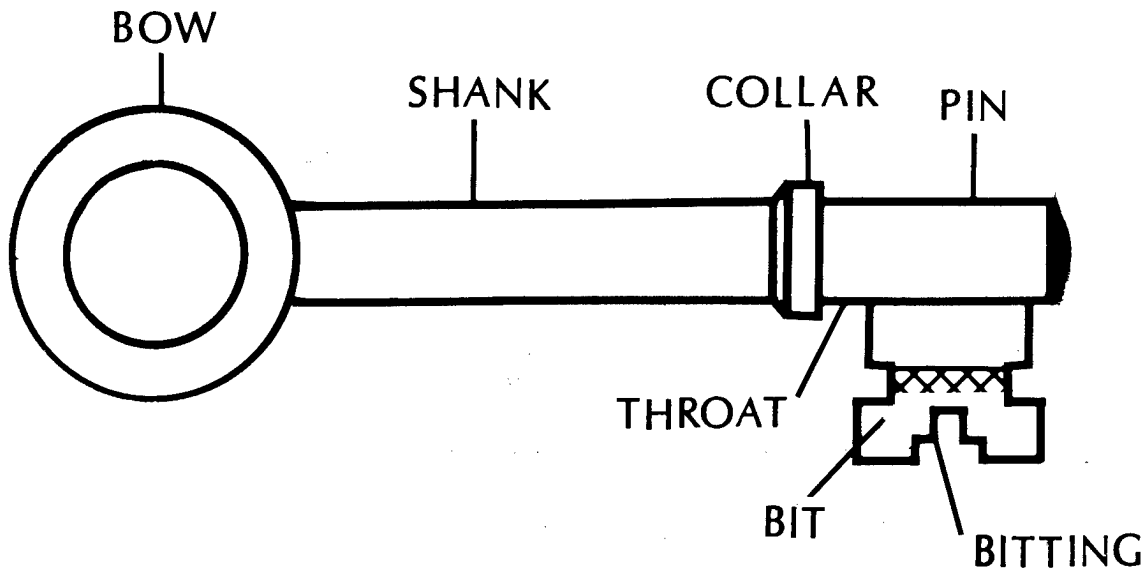
Figure 11-1. The Parts of a Warded Key. [Reprinted from The Complete Handbook of Locks and Locksmithing, copyright 1976 by TAB Books, Blue Ridge Summit, Pa., 17214. Compare this to Figure 10-1j.]
